MAINTENANCE ISSUES, RECOMMENDATIONS, AND SPECIFICATIONS

This section is a compilation of major maintenance recommendations for all trail field assessments in January and March, 2003. The issues and recommendations have been prioritized to help guide the park in implementation of work. The subsequent sections of this chapter contain detailed specifications on how to accomplish these projects. The highest priority maintenance needs relate to large volumes of water, moving at high speed along or across the trail, causing extensive erosion and gullyng of the treadway. Repairs needed include:

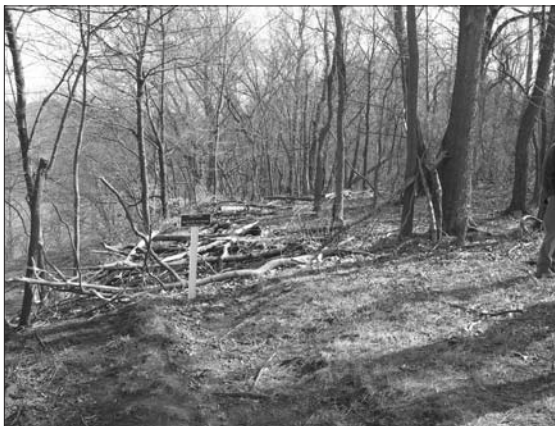
Figure 4.1. Entrance to unauthorized trail off Chapel Trail A requires ongoing brush covering to discourage use.

Recommendation: To minimize confusion for trail users, obscure closed, social, or unauthorized trails with random placement of large logs and branches that blend into the natural landscape. Also distribute leaf duff and organic matter to disguise and revegetate the treadway. Do not disassemble historic stonework or regrade historic traces (Figures 4.1-4.3).

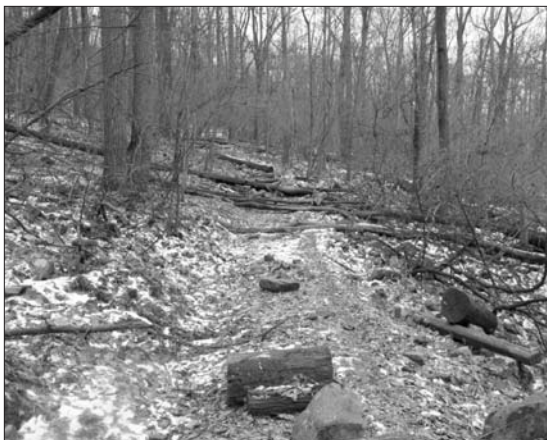
Figure 4.2. On closed Horse-Shoe Trail C, randomize debris and logs and distribute duff and other organic material to better disguise and revegetate treadway.

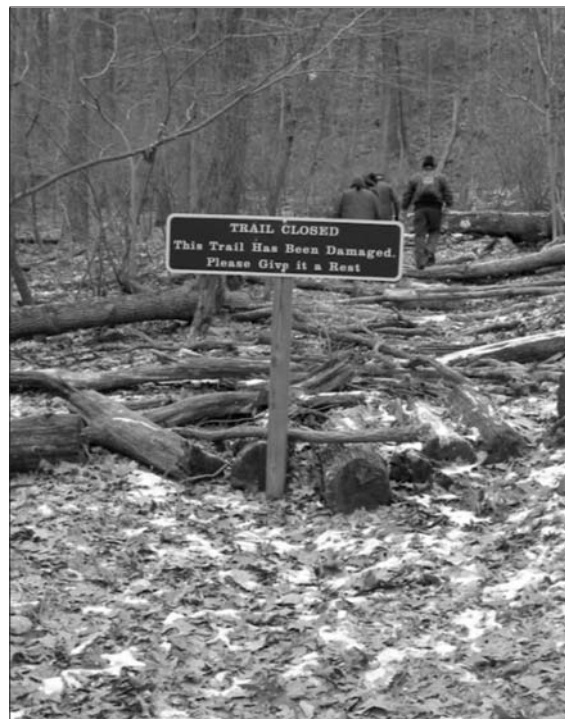
Figure 4.3. On closed Mount Misery Trail C, use larger dead trees with lots of branches to discourage

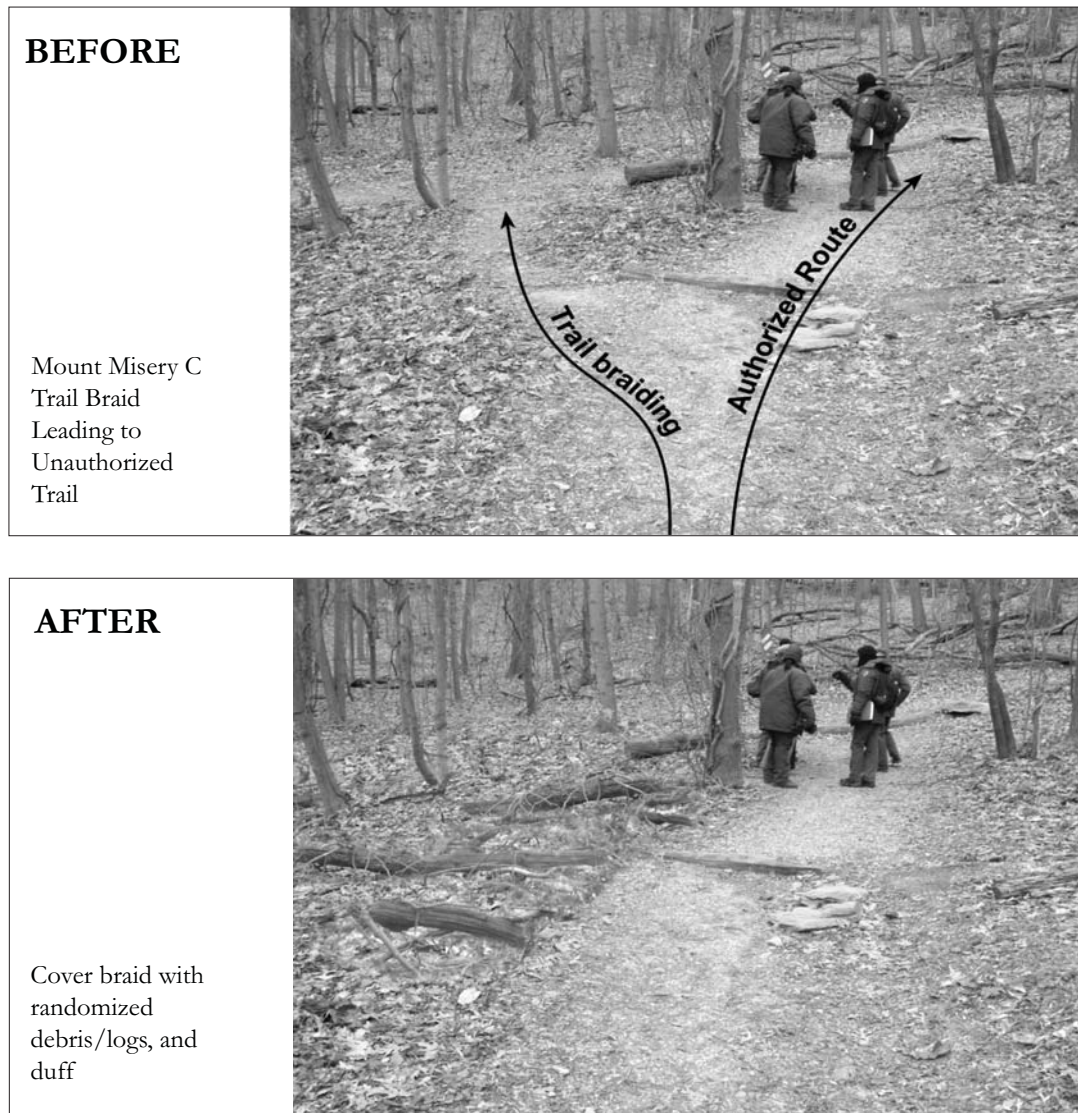
Figure 4.4. Example of a proposed closed spur covering project.

Implementation: Trail professionals or trained staff/volunteers should operate pulley and winching equipment. Groups of volunteers can cover entrances to unauthorized trails, hide social spurs, and deter trail braiding by dragging logs and brush, spreading organic debris and leaf duff, and checking trailheads to ensure that signs are not vandalized (Figure 4.4).

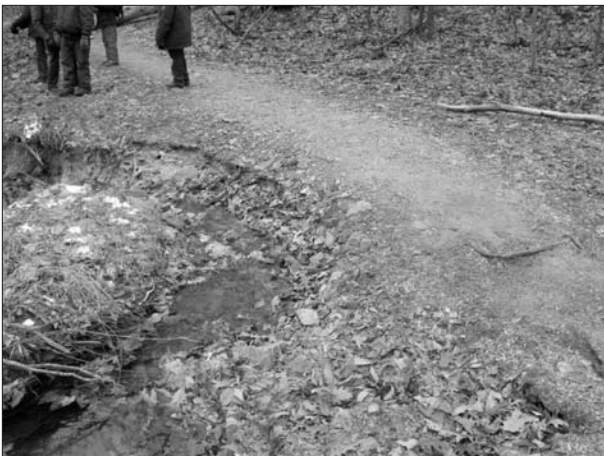
Figure 4.5. Section of Horse-Shoe Trail A is eroding as stream follows a different course after Hurricane Floyd in 1999, when the stream culvert became blocked and the rising water created an alternate channel around the dam. A short segment of trail should be rerouted away from the stream.

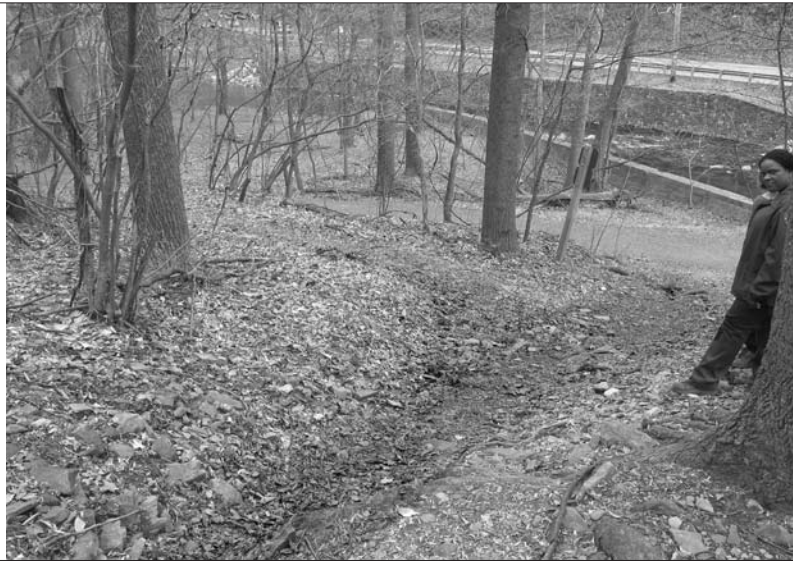
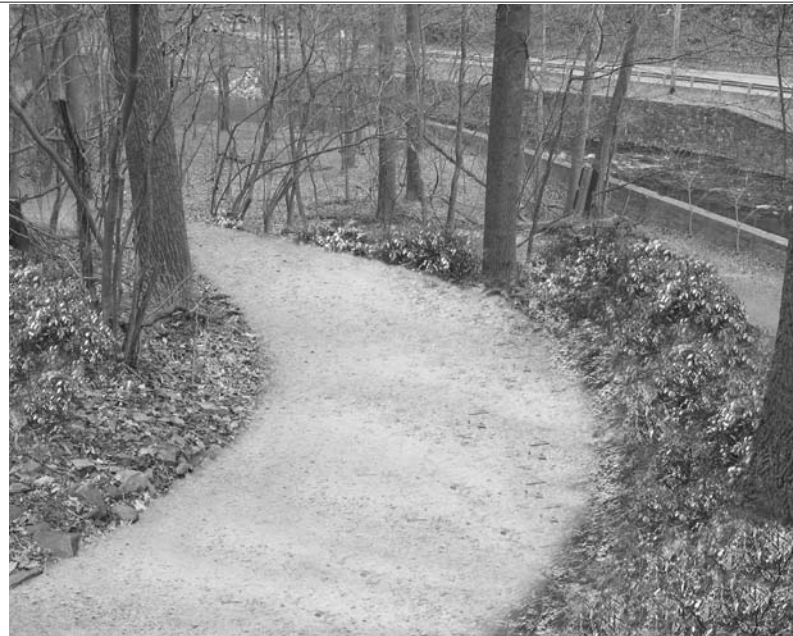
Figure 4.6. Example of a reroute on short segment of trail.

Mount Misery
B leads down
a huge gully
before reaching
Valley Creek
Trail

Recommended
stabilization
includes:
rebench the
trail to the left
(west), bring
tread to grade,
build checks
and rubble wall
at turn, install
drainage, then
revegetate area

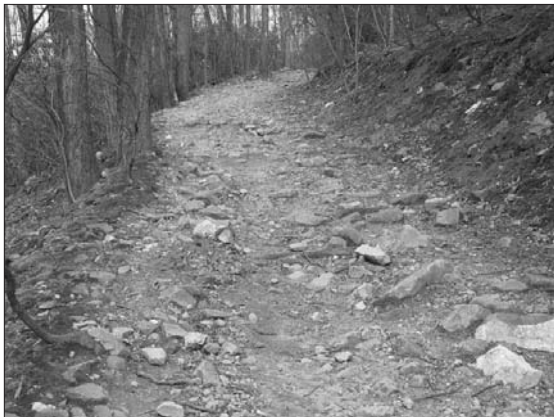
Figure 4.7. Overgrown vegetation on Horse-Shoe Trail A is causing hikers walk on delicate outer edge

Recommendation: Prune vegetation, particularly where branches have grown into the trail, causing users to widen the other side of the trail.

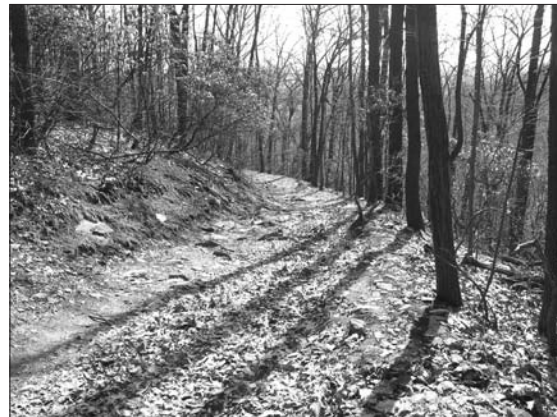
Figure 4.8. Vegetation is beginning to encroach trail on Mount Joy Trail F.

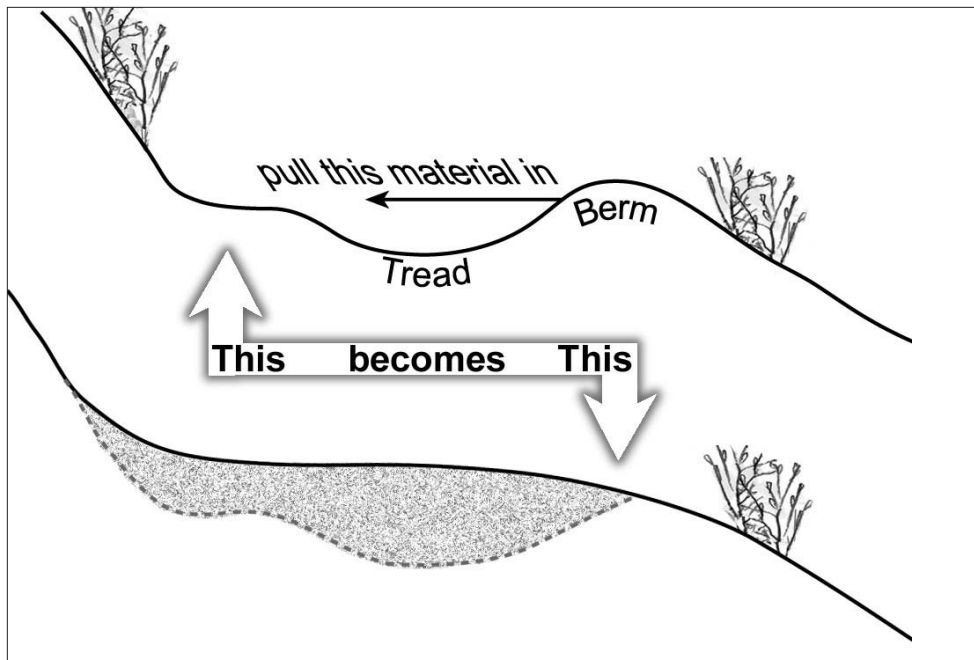
Figure 4.9. A benched trail that has lost its outslope needs to be restored by regrading the berm and adding material.

Recommendation: Sections of damaged bench-cut trail should be restored by removing the berm, regrading the outslope (Figure 4.12), and defining the edge of the treadway with vegetation, coping stones and other barriers. Barriers should be careful to work in conjunction with water bars and dips that are needed where the benched trail runs along a steep slope and water must be directed off of the trail.

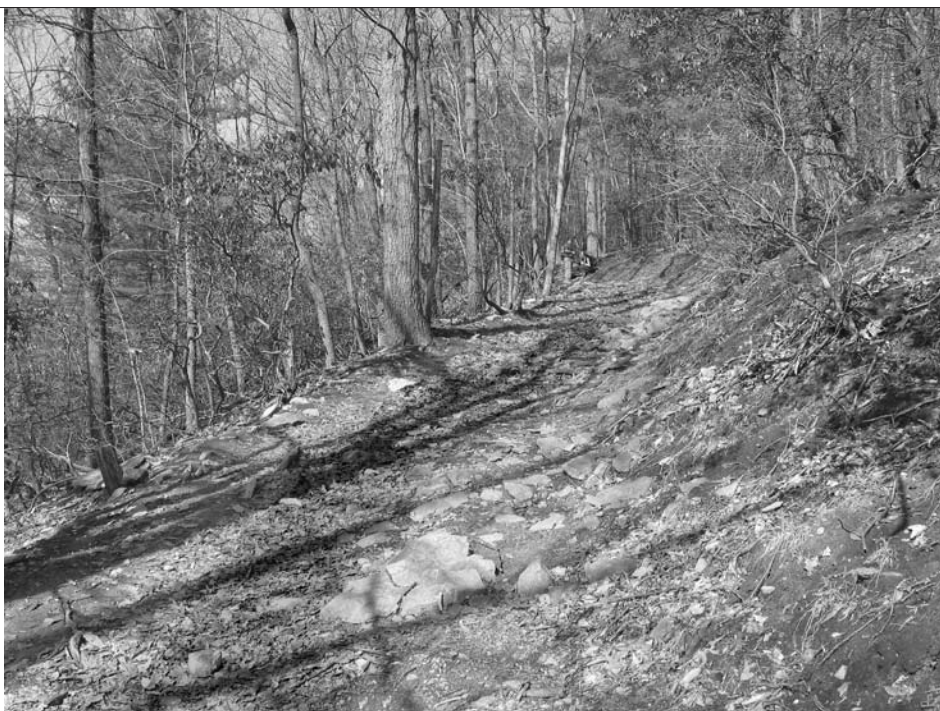
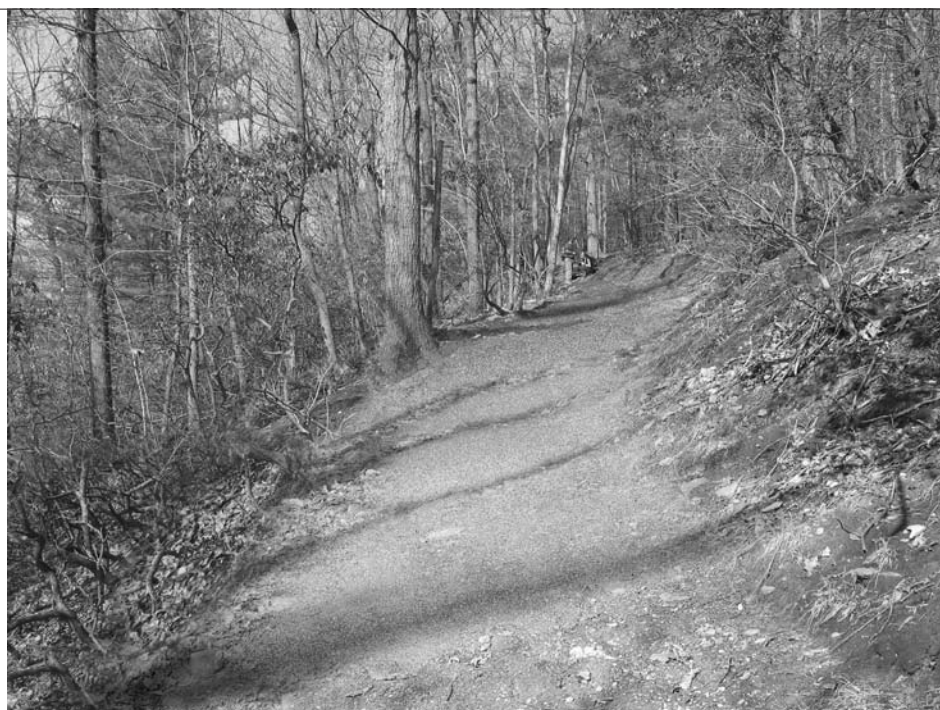
Figure 4.10. Example of a proposed rebenching project.

Mount Joy
F has lost its
bench and
outslope
and is gullying

Rebench and
pull in berm,
regrade with
material, drain,
and define tread
edge to keep
users on trail

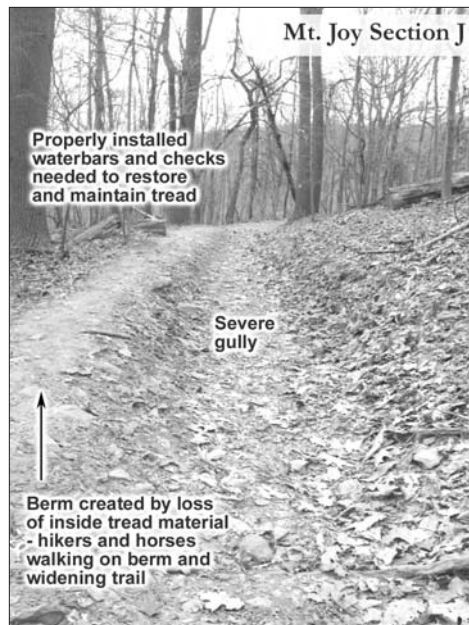
Figure 4.11. A section of trail that needs to be rebenched. Because the gully is long and deep, additional material will need to be hauled in.

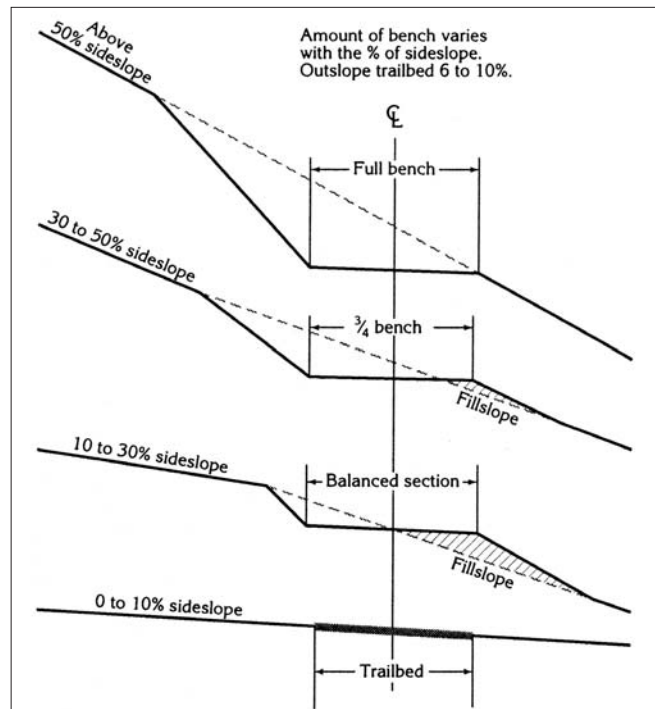
Figure 4.12. Specifications for benches. Where slumping has occurred, regrade slopes to reestablish the trailbed.

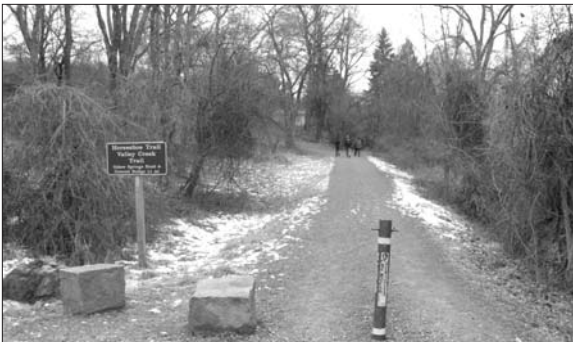
Figure 4.13. Section of Valley Creek Trail causeway that requires routine crown maintenance.

Recommendation: To protect further damage to resources and vegetation, build wall-less causeway, or maintain current wall-less causeway by resurfacing with new material to prevent loss of crown.

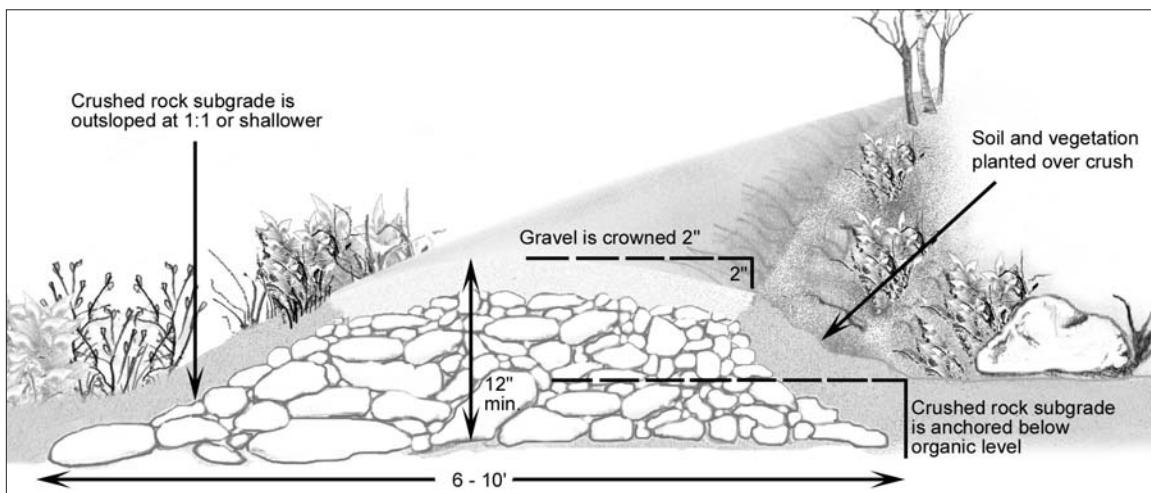
Figure 4.14. Diagram of wall-less causeway construction from specifications for Acadia National Park.

Specifications: Wall-less causeway is excavated below the organic layer and six to nine feet wide. A stone rubble base serves as subgrade needs to taper underneath string line outside treadway to its natural angle of repose. Finished causeway will have tread width of four to five feet, and the height of the crown will be at least twelve inches above the surrounding grade.

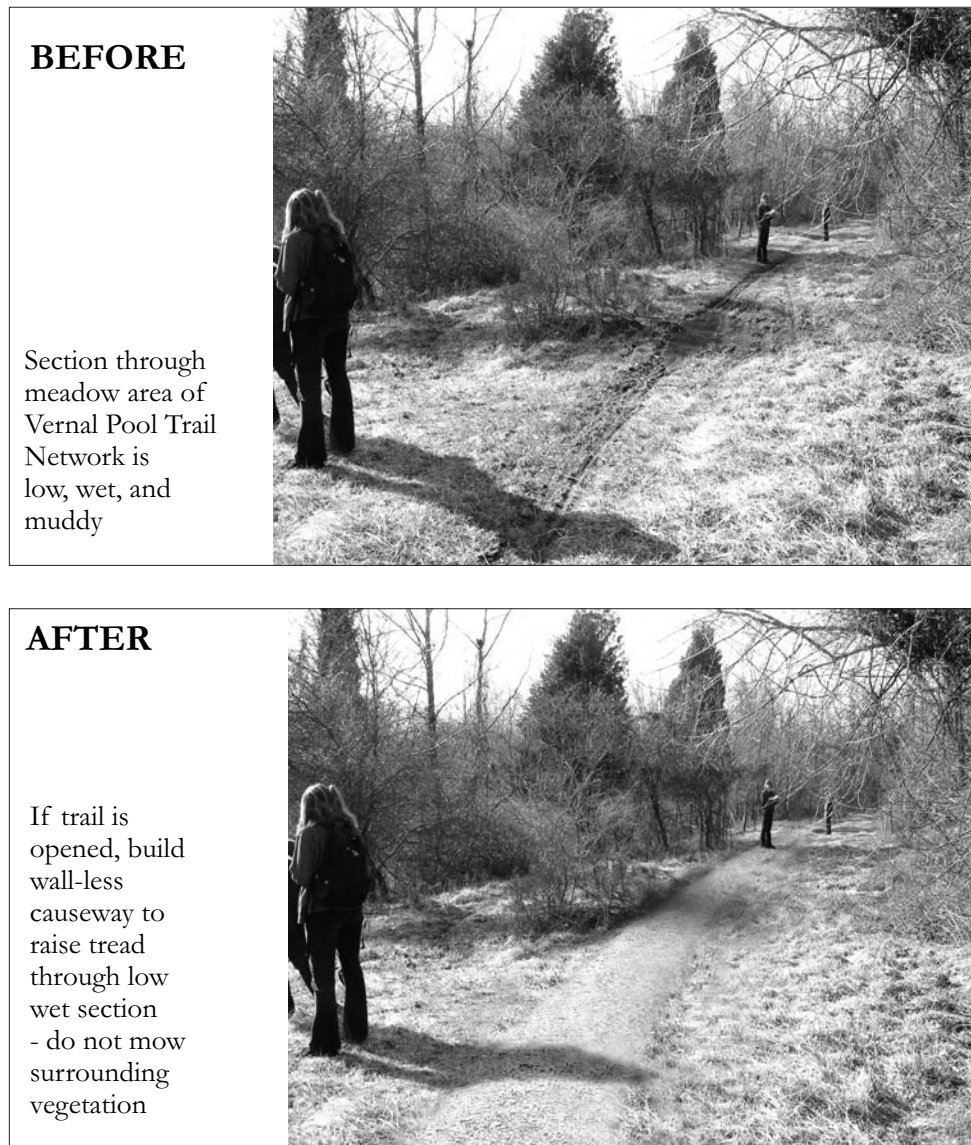
Figure 4.15. Example of a proposed wall-less causeway construction through low wet area of trail.

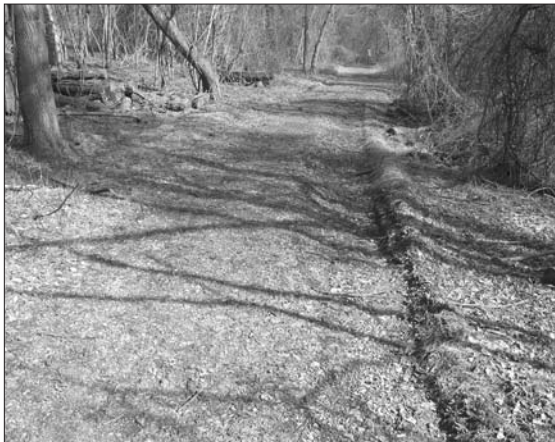
Figure 4.16. Catfish Lane Trail needs material to re-grade vehicle ruts

Recommendation: To protect natural and cultural resources, collecting gravel and stones from banks or streambeds is not appropriate at Valley Forge NHP. For major trail stabilization projects, a tread mix should be ordered from off-site sources and hauled to the work site.

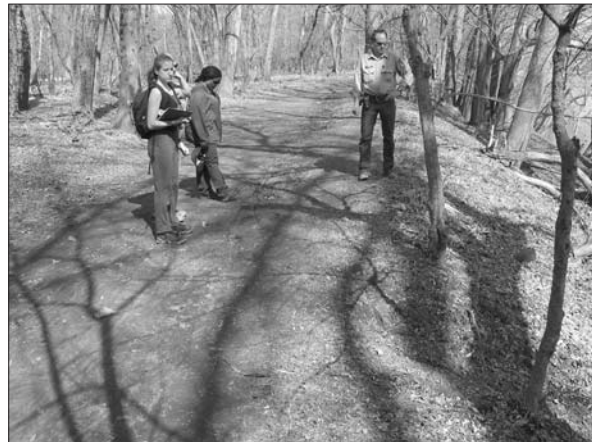
Figure 4.17. River Trail B loses material due to river flooding or material is covered in river silt.

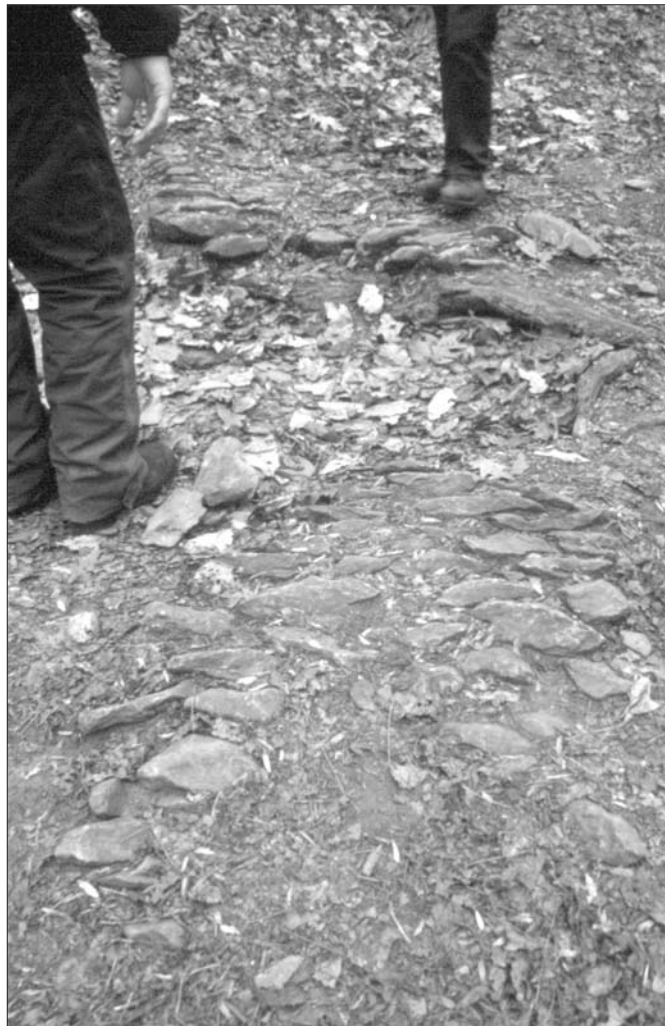
Issue: Remnants of stone paving were found on Mount Joy Trail J, where it is used to stabilize the tread where water flows across the trail (Figure 4.18). The stone pavement was carefully done and possibly dates to the original trail construction on Mount Joy. The stonework has not been maintained however, and is in need of rehabilitation. Similar stonework may be present on Mount Joy Trail I, but further investigation is needed.

Figure 4.18. Early stone pavement work found on Mount Joy Trail J.

Recommendation: Use local stone to stabilize the trail tread where there is light flow of water across the trail surface.

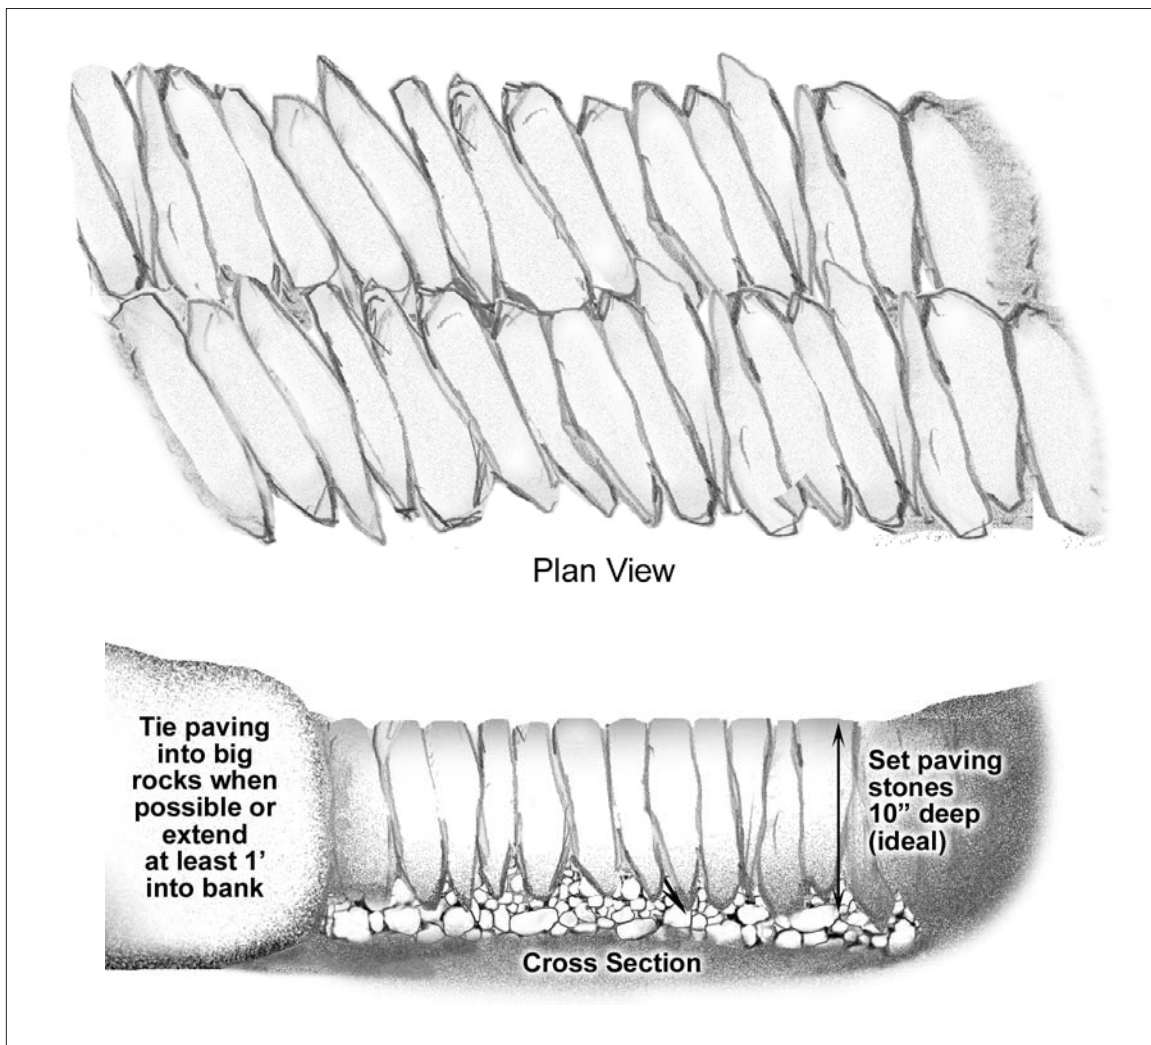
Figure 4.19. Method for stone paving construction using rocks indigenous to Valley Forge NHP.

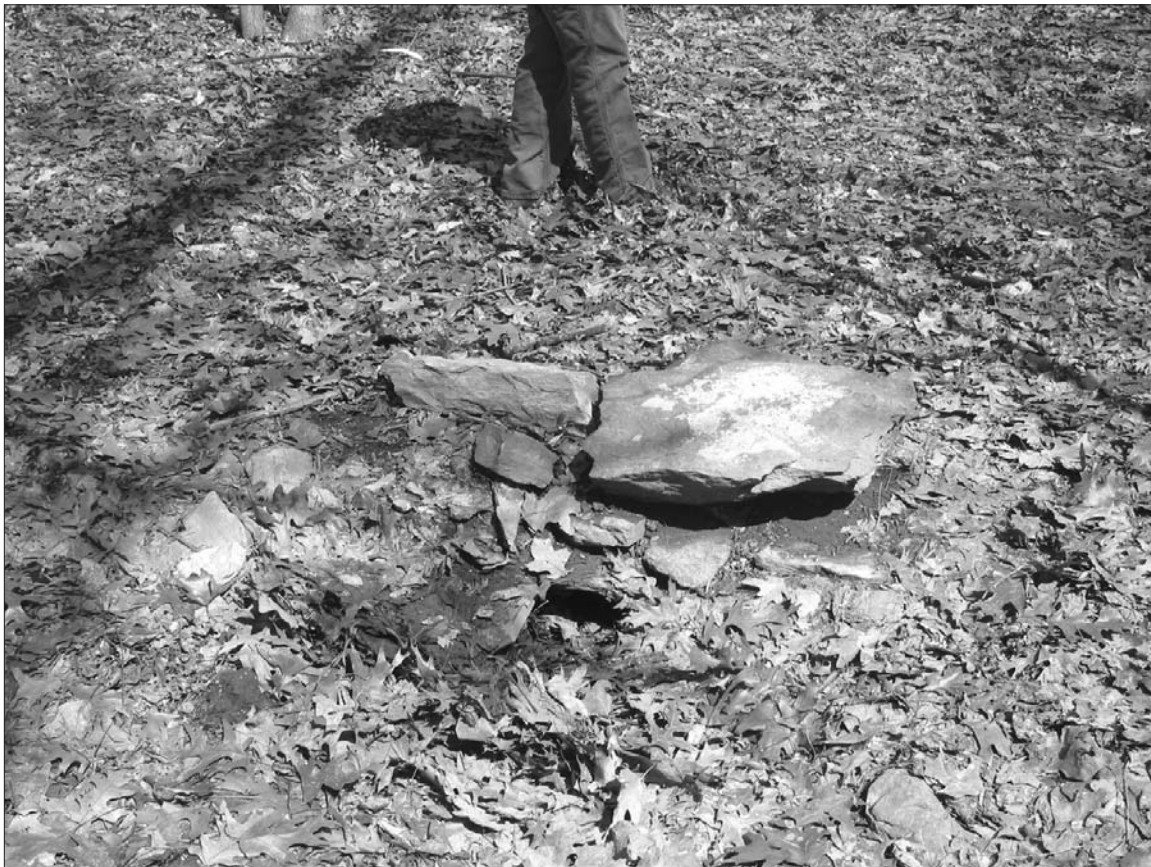
Figure 4.20. Pipe culvert under Mount Joy D at Mount Joy E (near Inner Line Drive intersection).

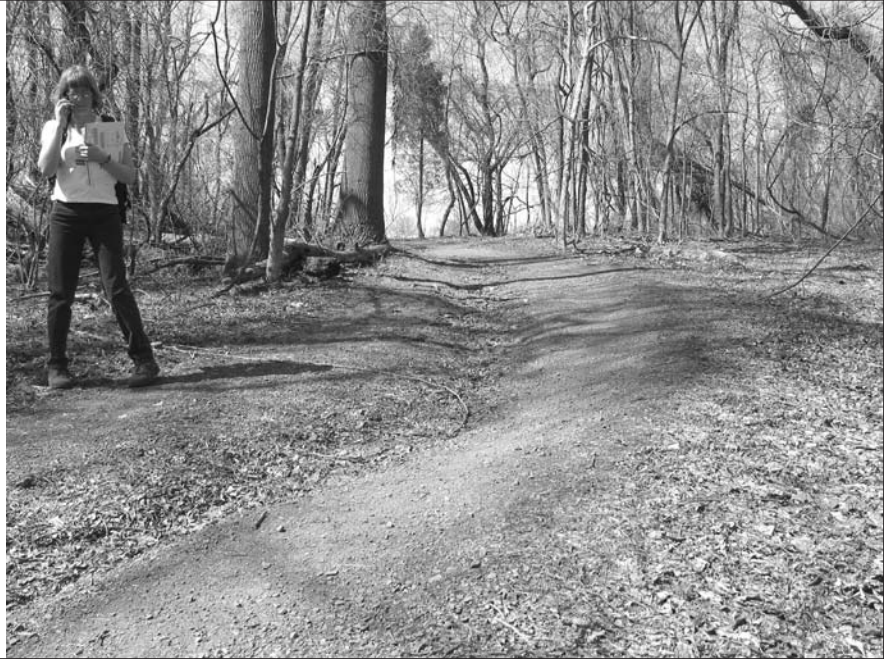
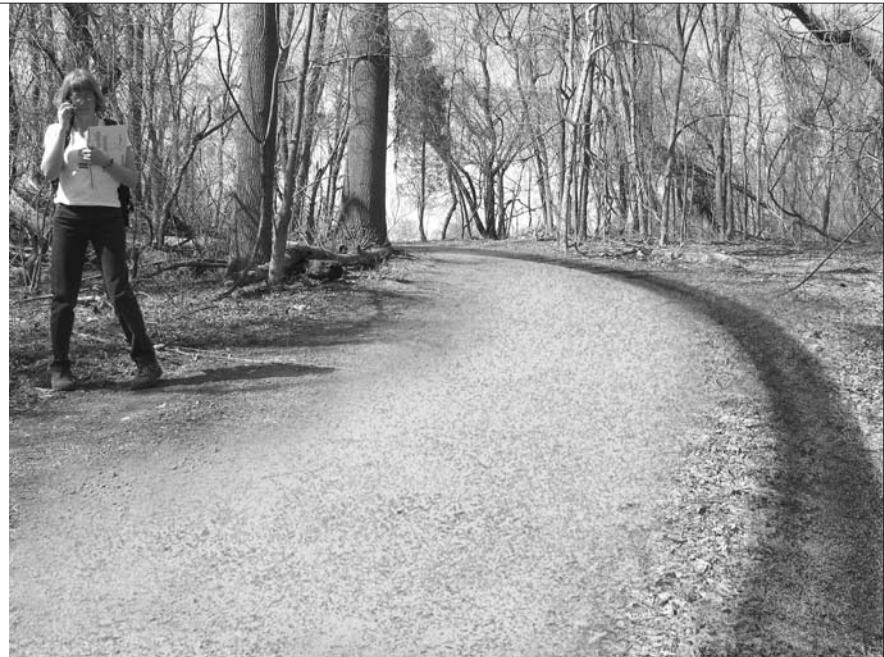
Figure 4.21. Example of proposed drainage digging project.

Section of Superintendent's Trail is draining down tread and resulting gully is causing loss of material

To rehabilitate, regrade trail and dig a drainage dip across trail (upper center of photo). Then extend ditch down the side of the trail. Provide outlet swales for the ditch wherever possible

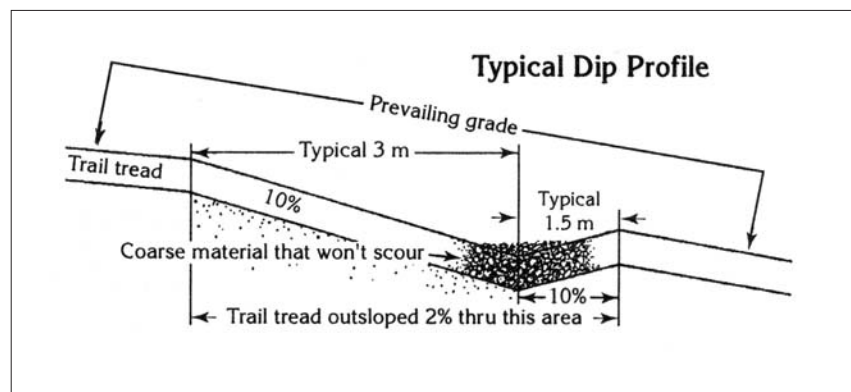
Figure 4.22. Drainage dip specifications from Lennon Hooper, *NPS Trails Management Handbook*, 1988.

Implementation: Trail professionals should flag the location and dimensions of dips and train volunteers to shape the dips. Dips that continually fill with silt should be rebuilt at a steeper angle. Those that scour should be reset at a shallower angle, or, if the flow is too great, replaced with water bars or another form of drainage. Those dips that flatten or are routinely overrun should, if already built properly, be replaced with another form of drainage. Volunteers can clean water dips annually and, if possible, following severe storms. During cleaning, the original, gradual shape of the dip actually should be restored and the outlet ditch dug out as far as is necessary to insure that water leaves the trail and does not re-enter. Care must be taken not to dig the depression too deep. Re-grade the ends of outlet ditches so that water can smoothly exit. With soil trails, material dug from the depression should be used to back up the water dip, rebuilding the reversal in grade.

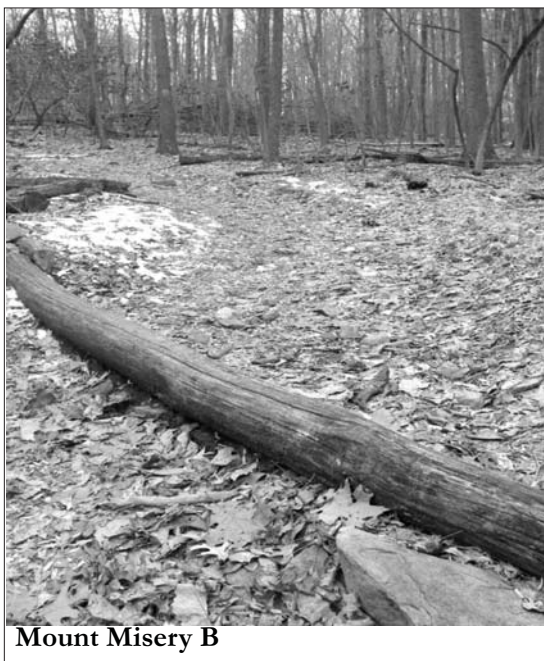
Issue: Water bars that have been installed incorrectly or have not been adequately maintained can become tripping hazards. Water bars that lack depressions on the uphill side of the bar to direct water off of the trail will become scoured and rise high above the tread, making them ineffective and tripping hazards. Bars that do not include anchors, which help keep hikers on the trail, will cause the trail to widened around the bars. Water bars that are poorly placed cannot shed water off the trail (Figures 4.23 and 4.24). These conditions were found on (for trail locations, see Drawings 1 and 2):

Figure 4.23. Existing water bars lack swales, are scoured, and need to be dug deeper into the ground.

Recommendation: Existing water bars should be reset and additional water bars added. Anchor stones, coping stones and log obstructions should be added to guide trail users but not obstruct drainage. Whether log or stone, when properly installed and graded, the top of the bar should be flush with surface on the downhill side of the water bar. Leaf duff can be added along the edges of the trail to better define the trail edges.

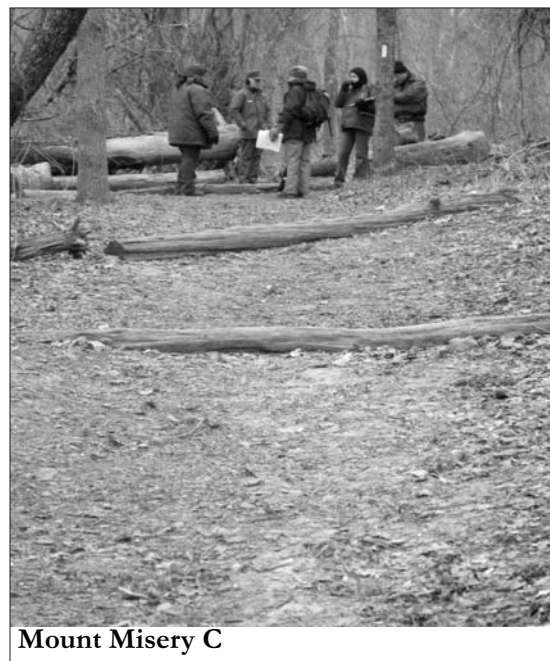
Figure 4.24. Anchor stones, coping stones and log obstructions are needed to keep hikers on the trail, and prevent widening.

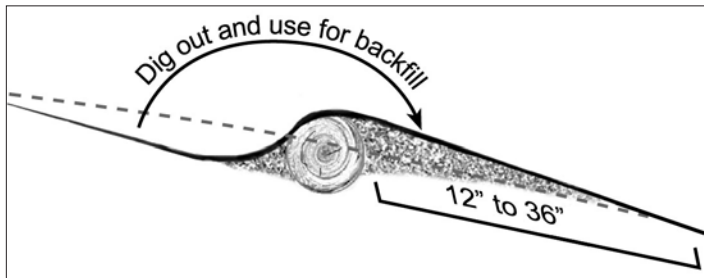
Figure 4.25. Bury the water bar below grade and dig a

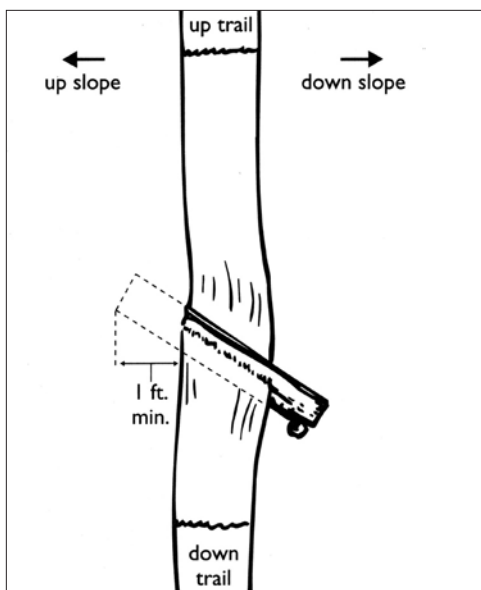
Figure 4.26. Set the angle of the water bar according to the steepness of the slope. From Robert Birkby, *Lightly on the Land*, 2000,

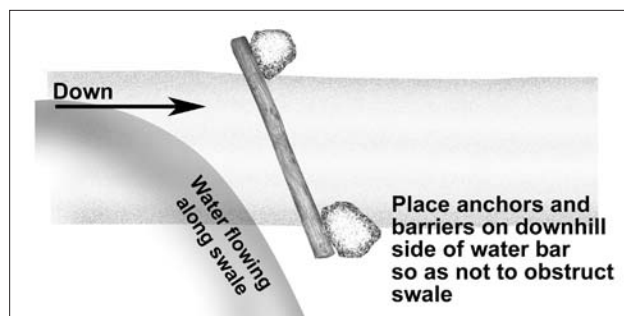
Figure 4.27. Basic water bar guidelines showing placement of anchor stones.

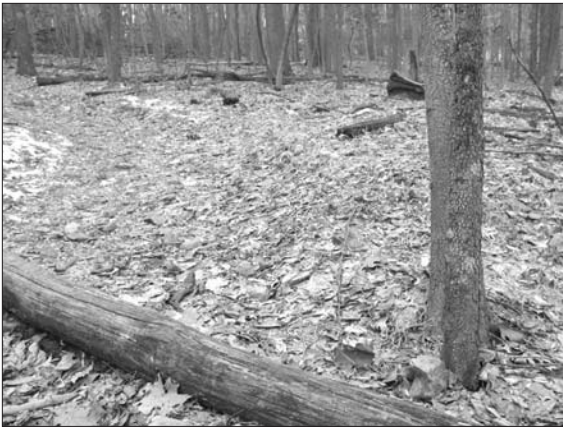
Figure 4.28. This water bar on Mount Misery B is too shallow and directs drainage into a tree.

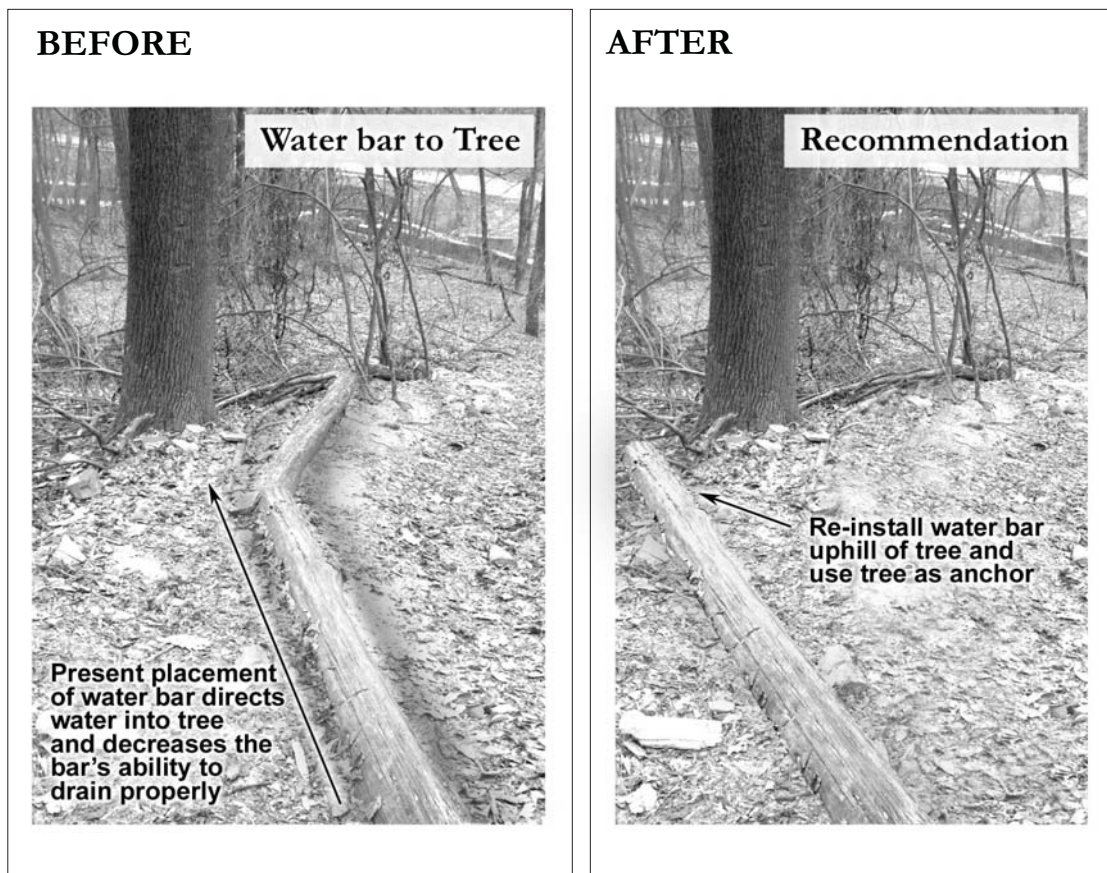
Figure 4.29. Water bar placement recommendation using example from Mount Misery B.

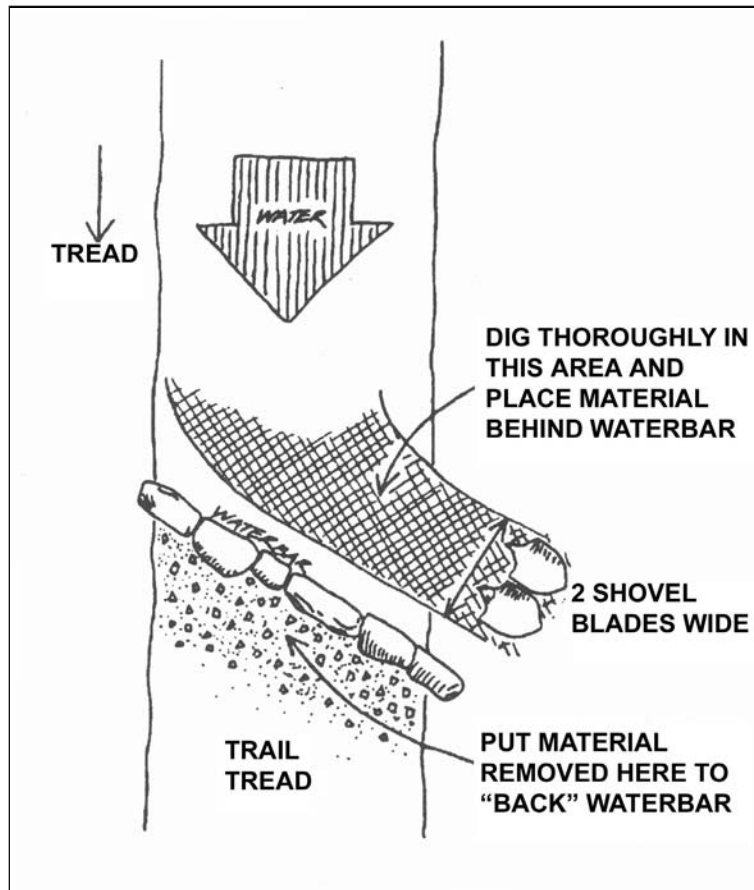
Figure 4.30. Specifications for swale construction (this diagram shows stone water bars, but swale specifications are the same for log). Diagram adapted from Stephen Griswold, *A Handbook on Trail Building and Maintenance*, 1996, 50.

Swale and Outlet Ditch Specifications: The swale or apron is the dip on the uphill side of the bar that directs most of the water off the trail before it reaches the bar itself (Figure 4.30). Construct a drainage swale in front of the water bar and use soil to backfill below the bar. The swale begins sloping toward the outlet ditch about five feet back from the bar, and reverses trail grade to slope up to the bar about a foot from it. Except in times of very heavy flow or poor maintenance, water does not travel along the bar, but down the swale to the outlet ditch. The total depth of the swale (measured from the top of the bar) should be between six and twelve inches, depending on the overall size of the water bar. For more details, refer to *Lightly on the Land: The SCA Trail Building and Maintenance Manual* by Robert Birkby (2000), page 132.

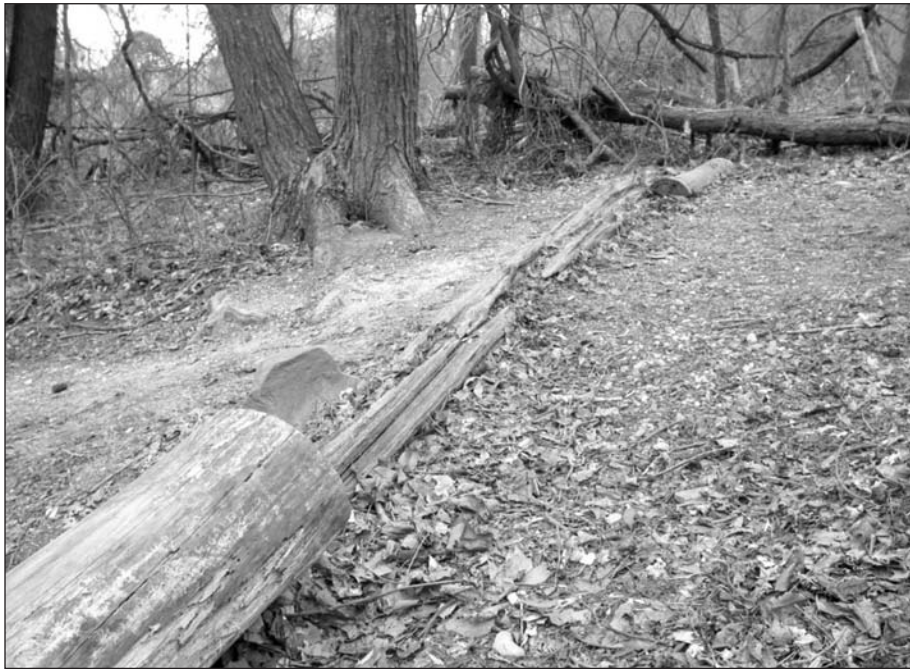
Figure 4.31. Replace decayed water bars such as this one on Mount. Misery B. The replacement bar should be set below grade with a swale and outlet ditch.

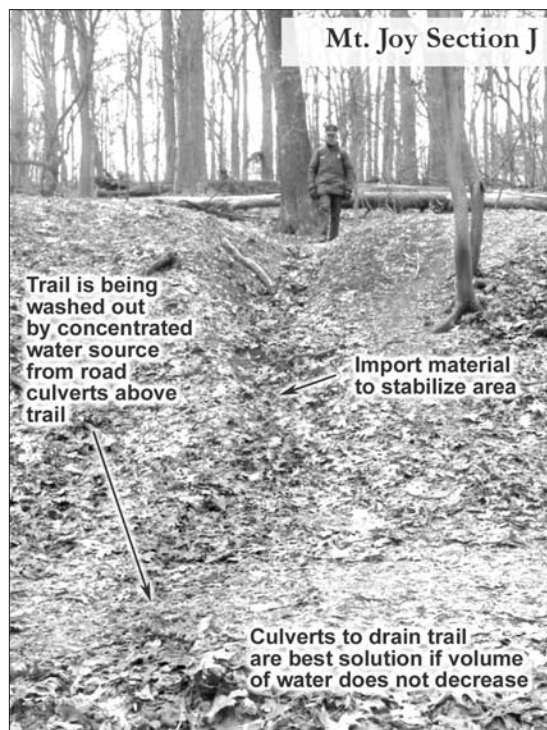
Figure 4.32. Gully from heavy water flow across Mount Joy Trail J.

Recommendation: Culverts are needed to handle heavy, concentrated water flow. Consultation with an engineer is needed to repair or replace ineffective culverts. The outlets of the existing culverts should be stabilized with rocks, retainer devices, and hardened to halt erosion. Once the water is slowed, it should be directed through a culvert located under the trail, and the drainage ditches must be cleared of debris as part of the regular trail maintenance routine. Additional rocks and retaining devices are needed below the trail to prevent erosion near archeological sites.

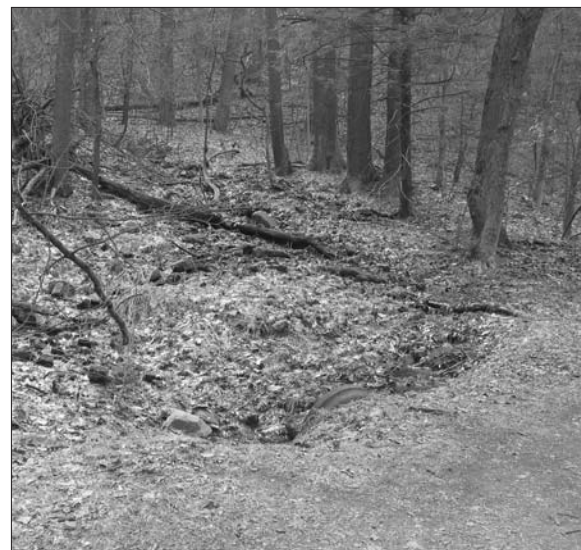
Figures 4.33. Drainage to culvert on Valley Creek Trail is blocked by debris, and water is draining across trail.

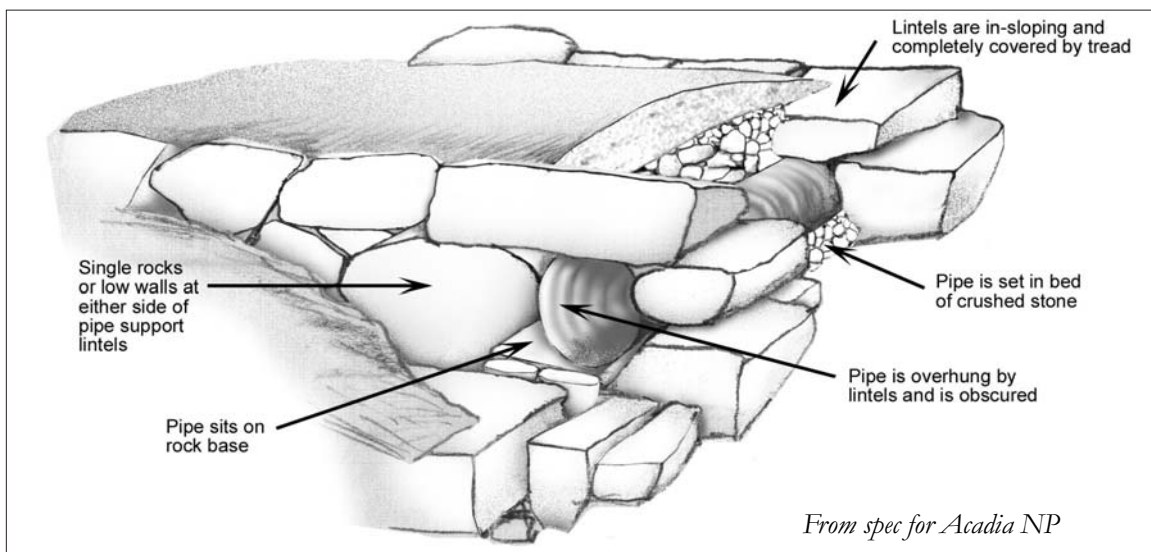
Figure 4.34. Specifications for a pipe culvert.

Stone rubble is laid in the drainage channel beneath the pipe. One pipe should be laid across the trail following the angle at which the water crosses the trail. Rubble is packed around the pipe to secure it and at least six inches of subsurface material is laid over the top to reduce frost heave.

The pipe should be obscured and protected at each end with a stone headwall. Headwalls should consist of two retaining walls, often each consisting of a single stone, one on each side of the pipe, with a single stone lintel across the top. The lintel should slope in toward the trail to hold gravel, and should be supported by the stone walls, not the pipe. Side retaining walls should be anchored well below the stone rubble base. Stone sizes will vary depending on the trail, but care should be taken that headwall and lintel stones are compatible in size and texture with existing work on the trail.

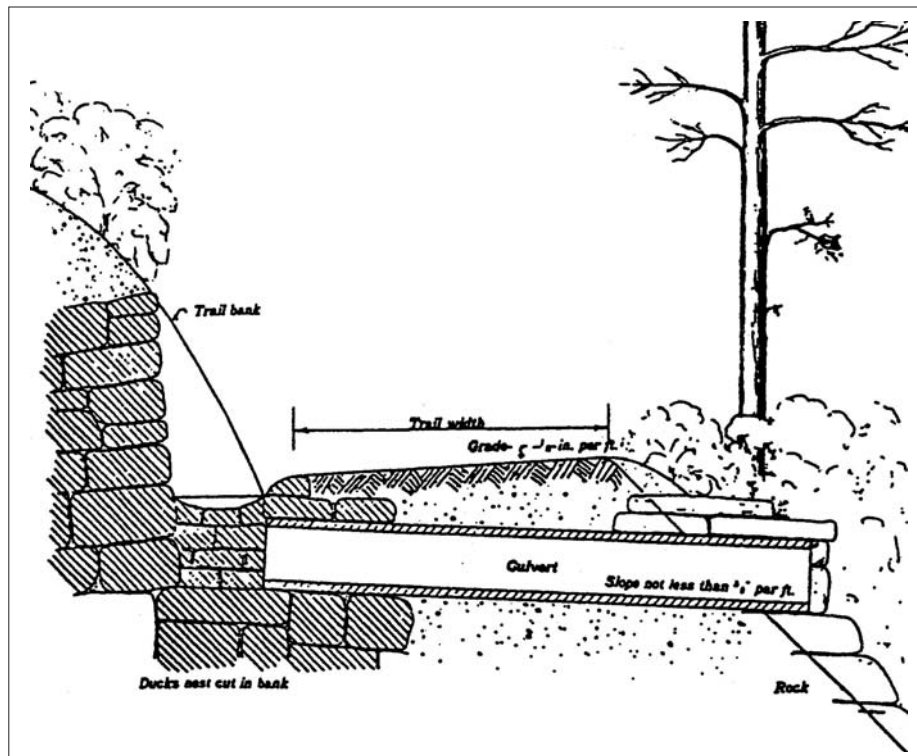
Figure 4.35. Civilian Conservation Corps specification for a closed culvert from Guy Arthur, *Construction of Trails*, 1937.
